Abstract

Structural Sandwich Performance After 31 Years of Service

By
JEROME PALMS, Engineer
and
GERALD E. SHERWOOD,
Engineer
Forest Products Laboratory,
Forest Service
U.S. Department of
Agriculture

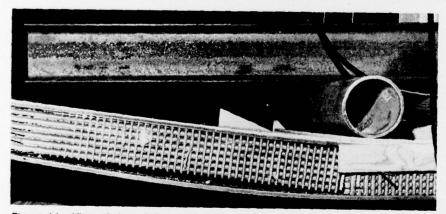
sandwich panels failed as a result of shearing in the core material. Particularly in plywood-faced panels with corrugated paper honeycomb core, shearing would occur in the core material alongside the glue line (fig. 14). Only in one pair of plywood panels (7N1, 7S1) was there evidence of failure in the glue bond itself (fig. 15).

Figure 14.—View of shear failure in the paper honeycomb core material along the glue line in a panel faced with plywood (panel No. 1N1). (M 147 103-7)

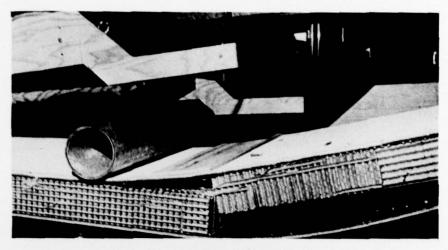
Figure 15.—View of shear failure in a panel with corrugated paper core and plywood facing. Some failure in glue bond was evident. Note that the shearing surface changes from lower inside facing to top at the point of interface between two sections of core material (panel No. TN1). (M 147 104-1)

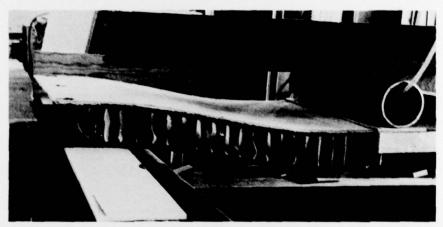
In the fiberboard-faced panels (3N4, 3S4), a layer of fiberboard had pulled away, with the bond between glue and fiberboard completely intact. Failure in these two panels was accompanied by wrinkling of the core material (fig. 16), which was frequently the case with the expanded type of paper core.

Figure 16.—View of failure due to shear in a panel with fiberboard facings and expanded type of core (Panel No. 3S4). (M 147 139-11)

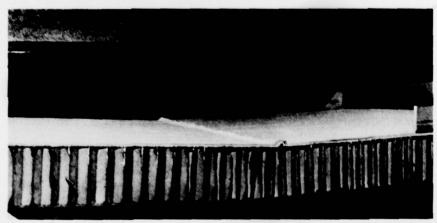
Aluminum-faced panels failed in local buckling in the top compression facing by suddenly bulging out from the core. Close observation revealed that when the facing had separated from the core, the adhesive had not adhered to the aluminum surface. Paperboard-faced panels also failed in compression of the top facing that resulted in local buckling (fig. 17).

Figure 17.—View of failure in paperboard facing due to local buckling on compression side (Panel No. 1N2). (M 147 103-1)
